ADDENDUM  
FIELD INVESTIGATION REPORT  
HYDROLOGY ANALYSIS  
3M REDDING HARD-ROCK AGGREGATE QUARRY  
SHASTA COUNTY, CALIFORNIA

Prepared for  
Resource Design Technology, Inc.  
January 21, 2010

BROWN AND CALDWELL

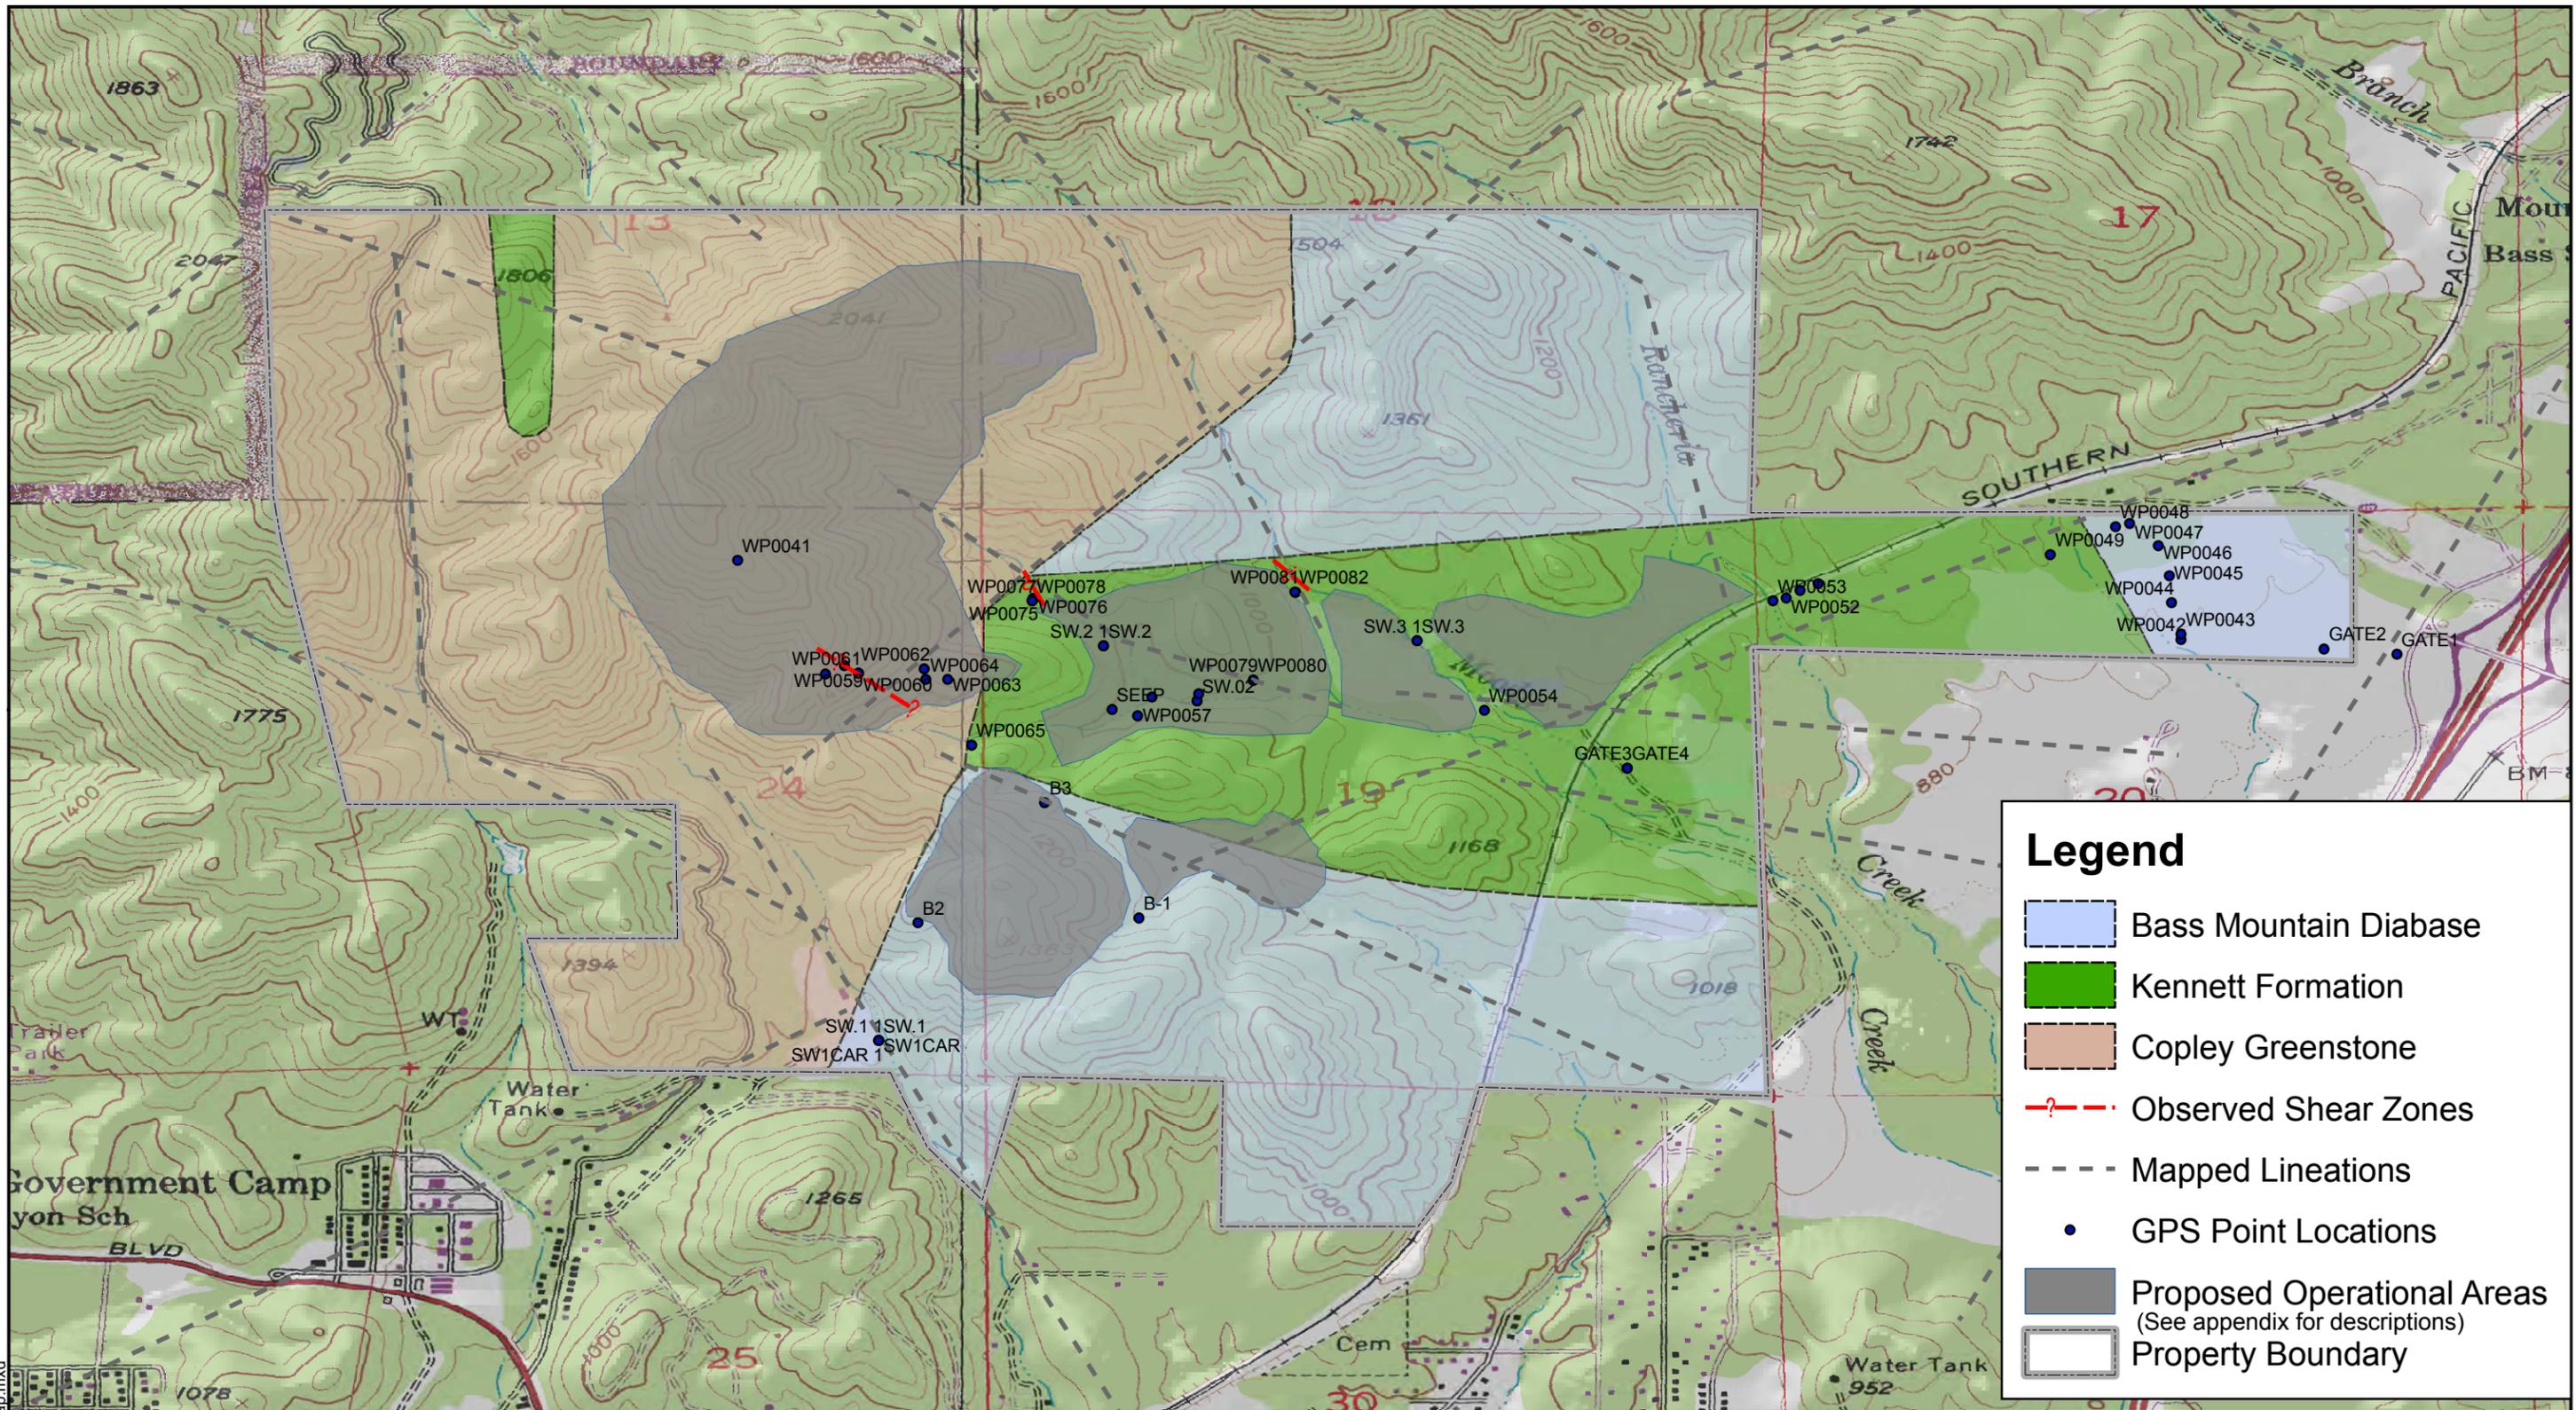
SITE	Proposed 3M Quarry Moody Creek, CA	
TITLE	Geologic Map and Lineation Assessment	
<b>BROWN AND CALDWELL</b>	PROJECT	137108
	DATE	1/21/2010
	Figure	2

The results of the field mapping program are summarized on Figure 2. Photographs of the representative rock types are also presented in Appendix C. As seen on Figure 2, the results of the field mapping are generally consistent with the mapping of the USGS (1906) whereby the site is directly underlain by deposits of the Copley Greenstone, Bass Mountain Diabase, and the Kennett Formation. The one discrepancy between the results of this field mapping program and the 1906 map is that the Bass Mountain Diabase was observed over the eastern portion of the property as opposed to the Kennett Formation. Brief descriptions of each of these units as observed in the field are provided below. During the field mapping program, specific areas were marked with a global positioning system (GPS). These points are designated as WP0042 through WP0082 on Figure 2. For descriptive purposes, features shown on Sheet 2, such as “North Pit”, “South Pit”, from a Resource Design January 2009 is also used for reference. A copy of this figure is provided in Appendix D.

Below the area of the top of the proposed North Pit, starting at an elevation of approximately 1,400 feet above mean sea level (feet msl) a shear zone was noted (WP0058 through WP0061, Figure 2). In this area the rock is very hard, black, highly altered and fractured and in some areas drag folds were observed (Photographs 7 and 8). Calcite deposits were also observed within some fractured zones. Small amounts of seepage were observed through some of the fractures near the lower elevations of this area (Photograph 6, Appendix C). The trend of this fault was measured at 90 degrees azimuth (east to west) with an apparent high angle dip.

**Kennett Formation:** (Photographs 9 through 28, Appendix C) The Kennett Formation was observed within the central portion of the site as shown on Figure 2. The proposed Overburden Storage Site, Plant Site, and Stockpiling and Loadout areas are located on this formation (Appendix D). The 1906 USGS map also shows a small outcrop of this unit in the northwest portion of the site. Since this area was not observed during the November 12, 2009 site visit, this outcrop of the Kennett Formation was included on the geologic map produced for this investigation as shown on Figure 2.

In the eastern portion of the Site (WP0049 through WP0053, Figure 2), this formation consists of yellowish brown to reddish brown thinly bedded mudstones with trace amounts of interbedded black chert. Bedding planes are apparent with thicknesses up to 3 inches. The thickness of most

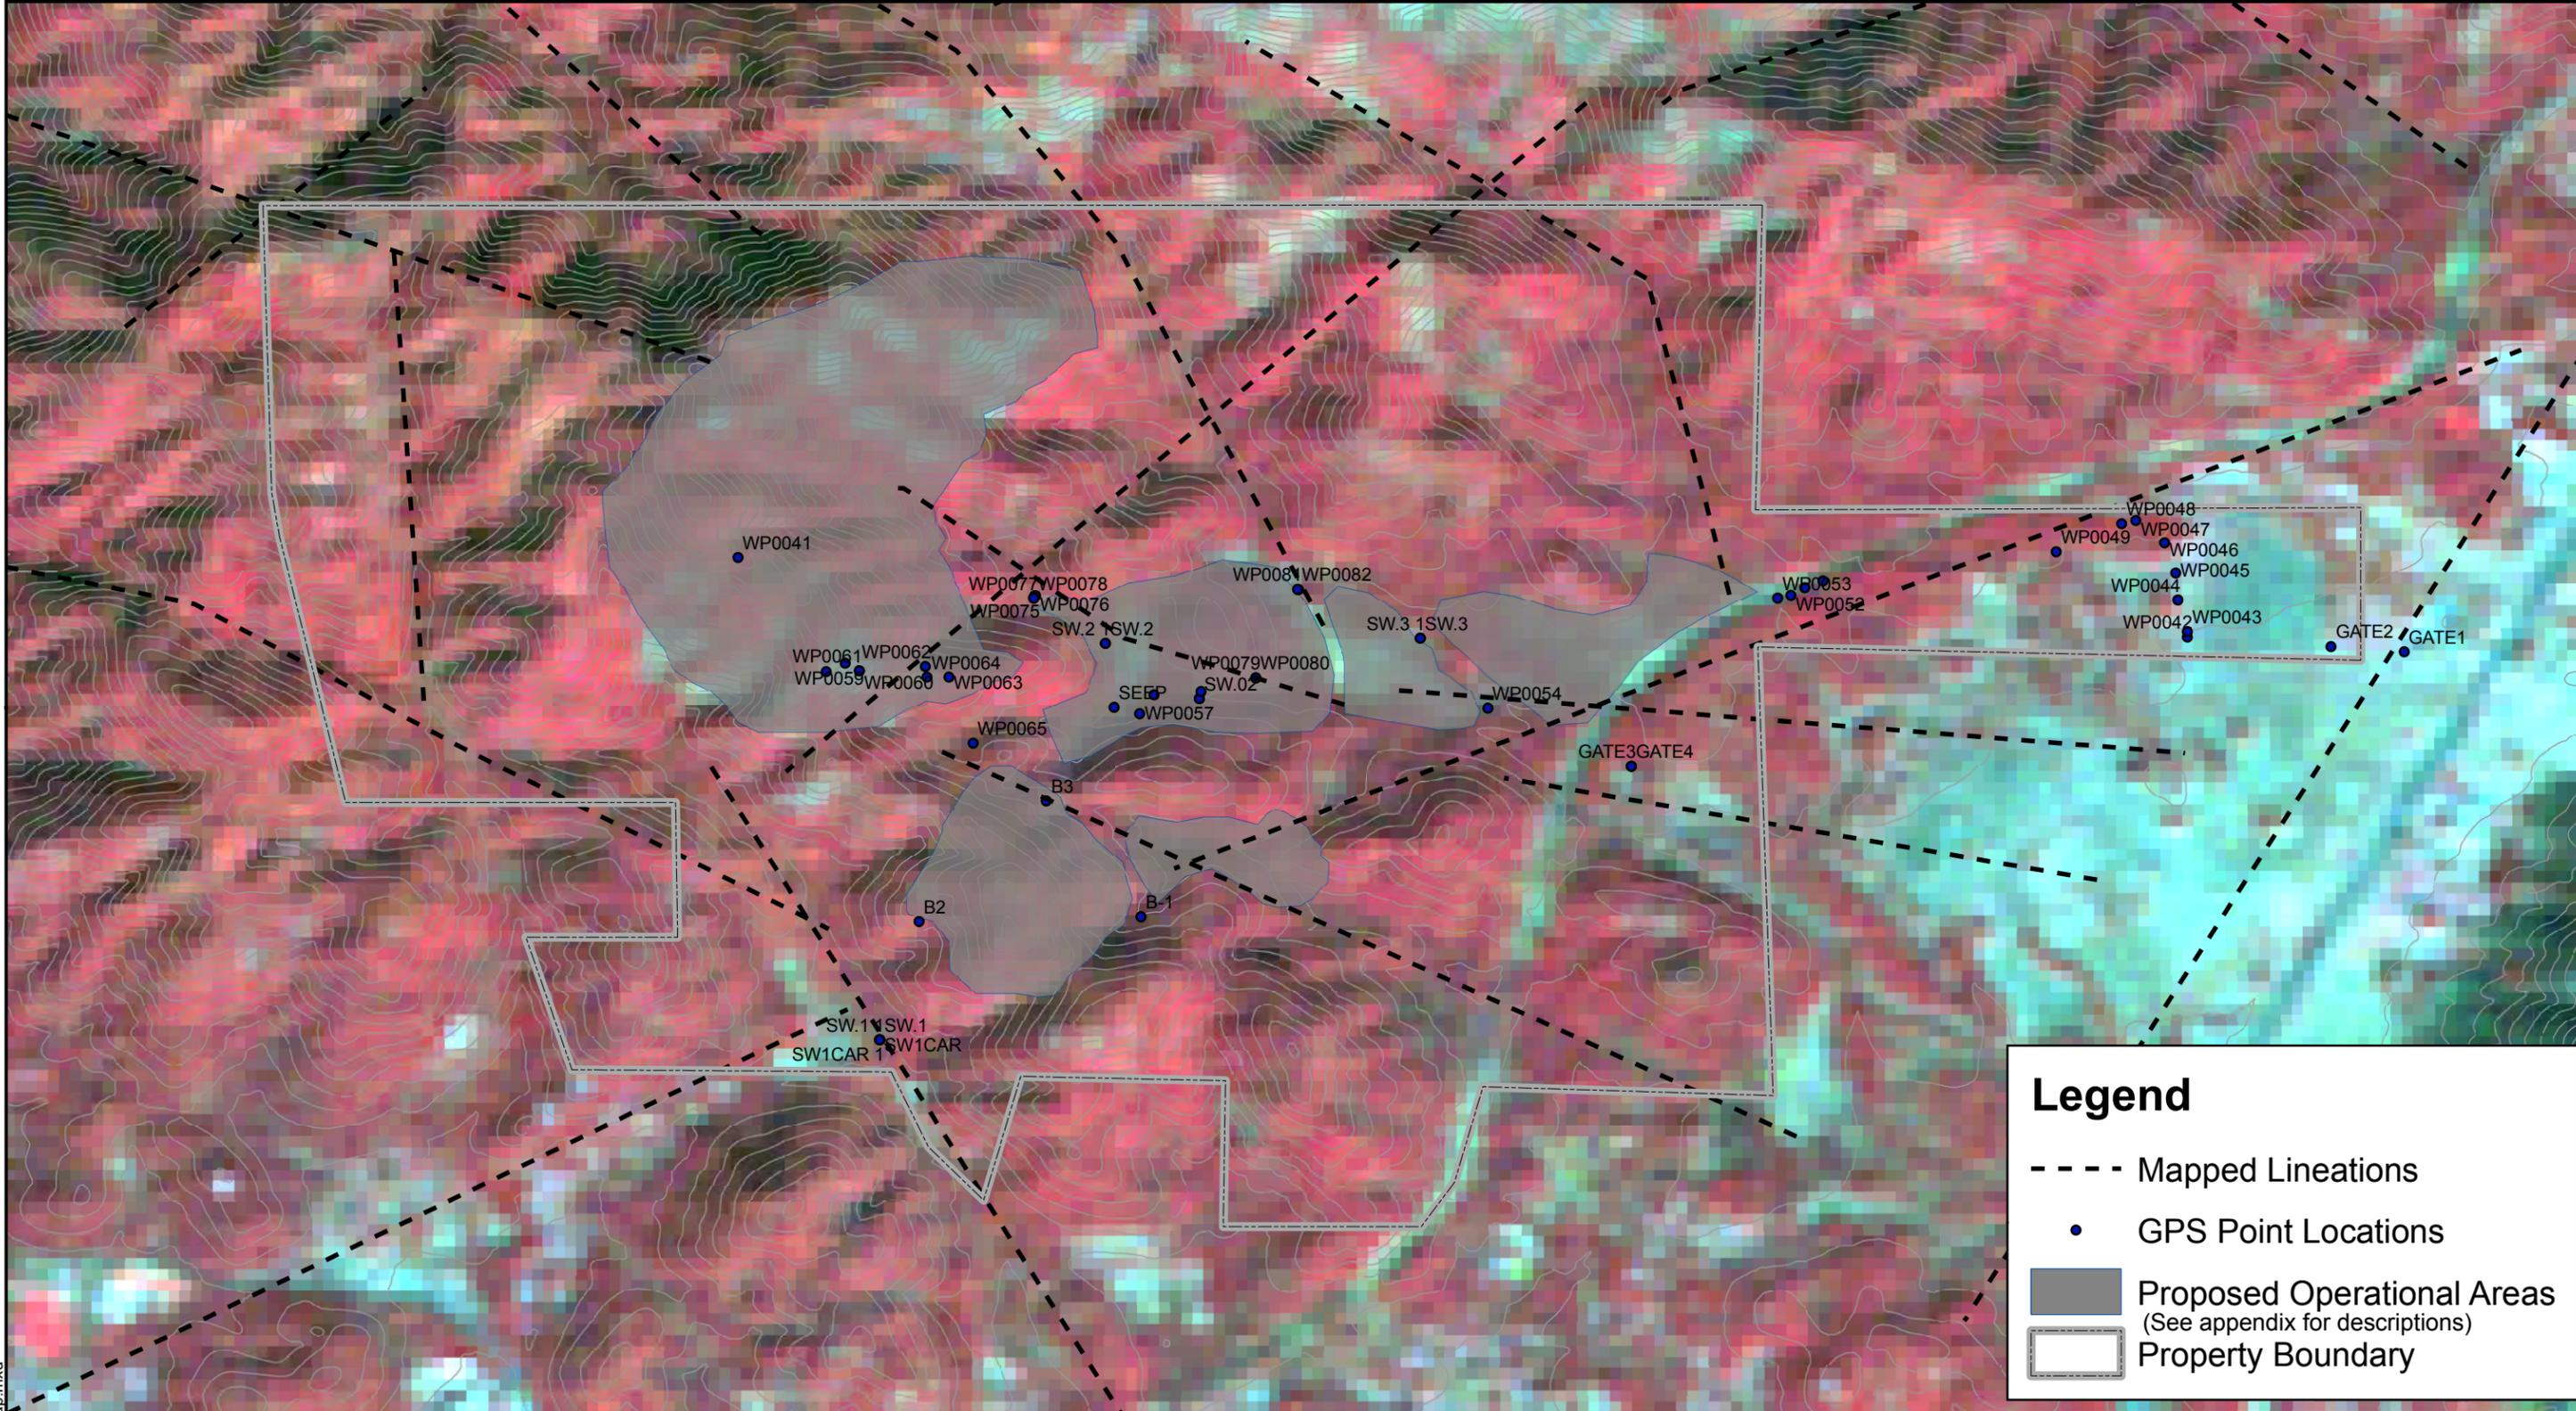
SITE		Proposed 3M Quarry Moody Creek, CA	
TITLE			
LANDSAT Based Lineation Assessment			
BROWN AND CALDWELL	PROJECT	137108	Figure B6
	DATE	1/21/2010

This study used readily available spatial data including aerial photographs, USGS topographic maps, digital elevation model (DEM), and LANDSAT images. The DEM was used to visualize landform in three primary figures, slope analysis, aspect analysis, and a contour density analysis. Each of these figures provides some insight to visually evaluate linear features. The figures generated are included in Appendix B.

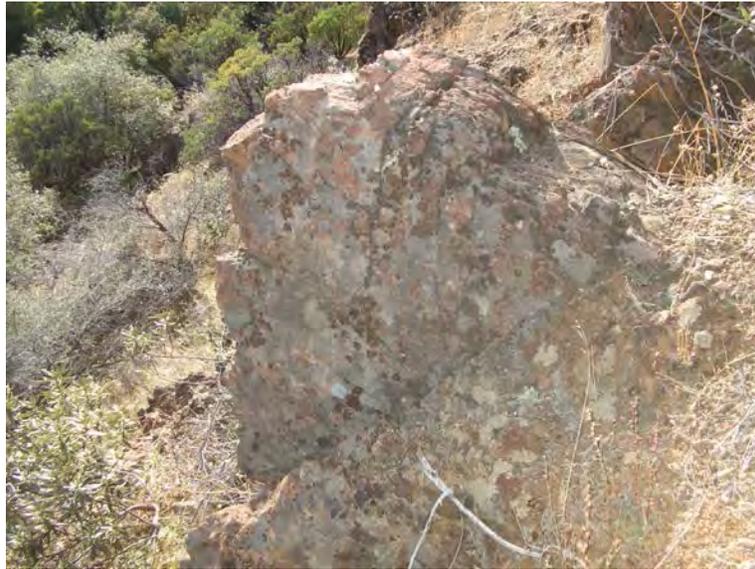
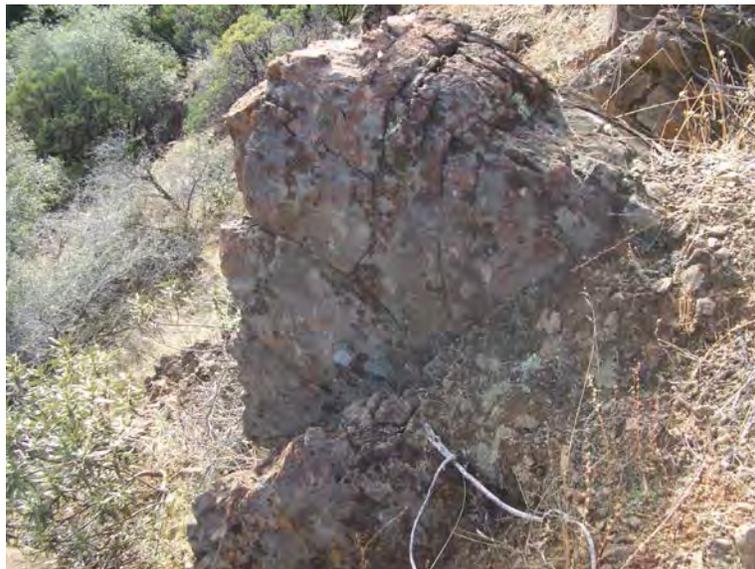
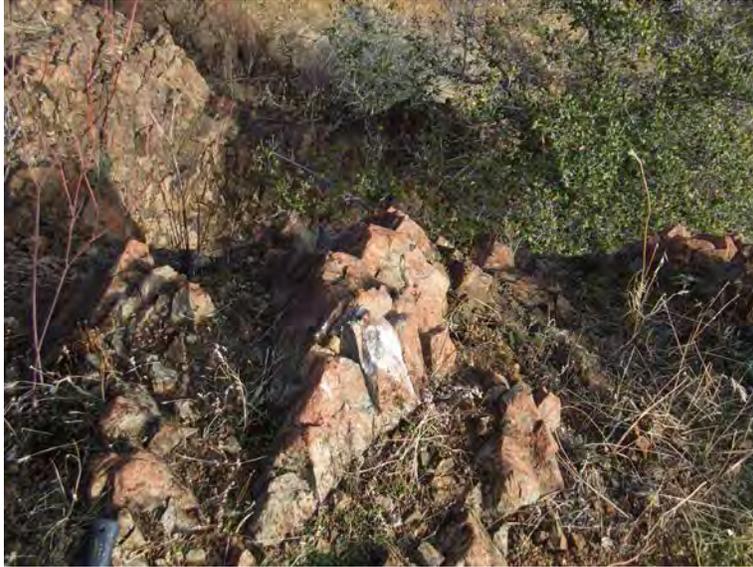
**Copley Greenstone:** (Photographs 1 through 8, Appendix C) The Copley Greenstone was observed over the majority of the western portion of the site including all of the proposed North Pit area. In this area it is generally pale green to pale red on weathered surfaces and pale green to darker green in fresh surfaces. Exposed rock services indicate a fine grained matrix with few phenocrysts. At the top of the peak in the area of the proposed North Pit, exposures contain vesicles filled with quartz. Rinds around the quartz fillings are visible using a hand lens within most of the filled vesicles.

In areas outside of the shear zone, fractures and joints within the Copley Greenstone are widely spaced and mostly closed. Some fractures were observed with openings up to 0.07 inches (Photographs 2 and 3). Two orientations measured for these fractures were 84 degrees azimuth with a dip of 45 degrees to the northwest and 99 degrees azimuth with a dip of 49 degrees to the southwest. No water seepage was observed in this unit outside of the shear zone.

Photograph 1 – Outcrop near proposed North Pit

Photograph 2 – As for Photograph 1

Photograph 3 – As for Photograph 1

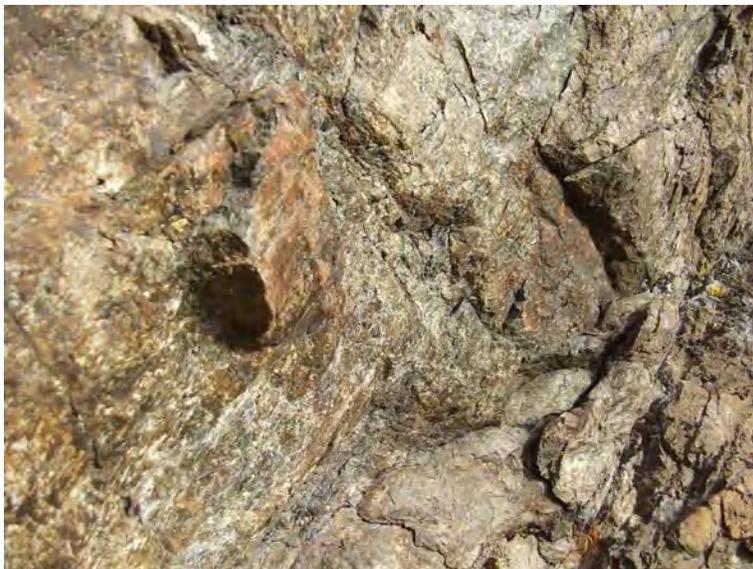
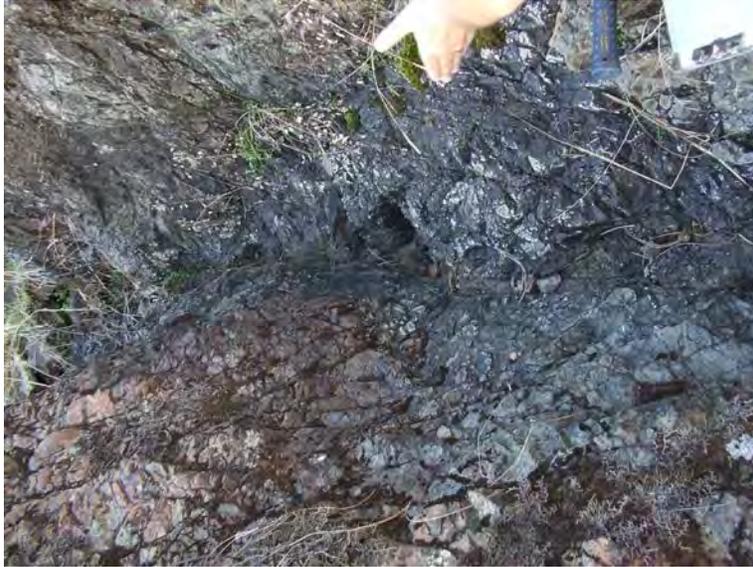
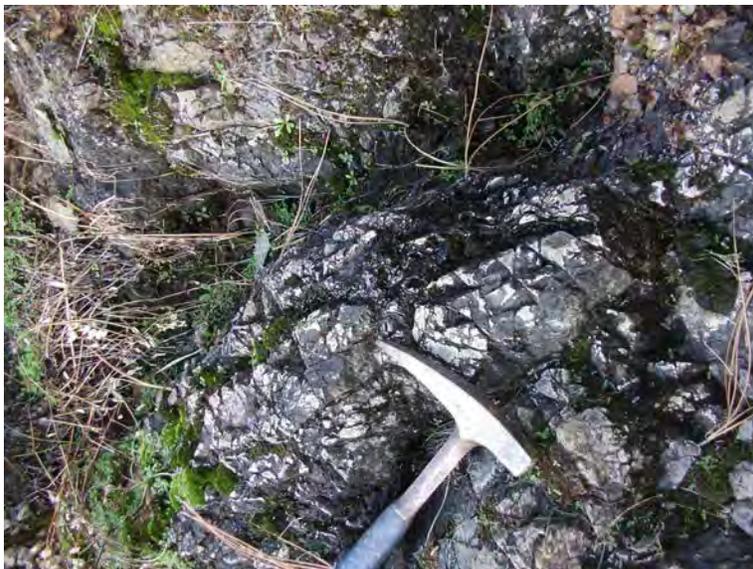
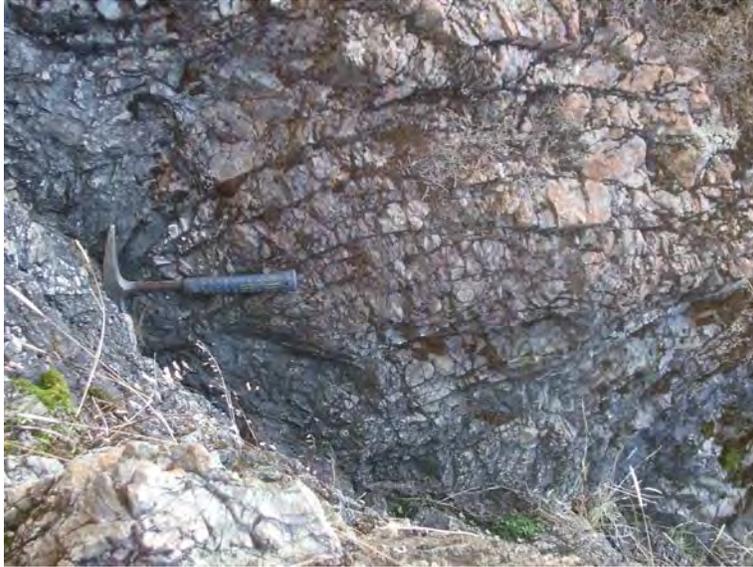
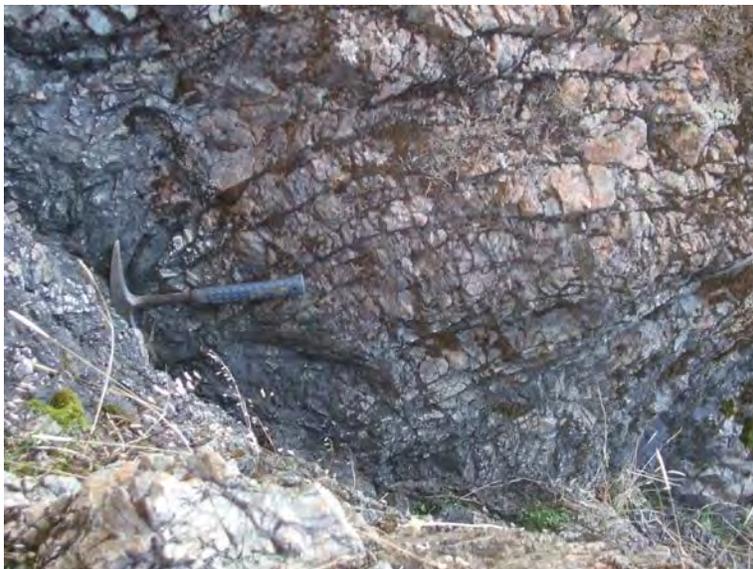
Photograph 4 – Shear Zone area, Slickenside present

Photograph 5 – Shear Zone – Water Seepage

Photograph 6 – As for Photograph 5

Photograph 7 – Shear Zone – Drag Folding

Photograph 8 – As for Photograph 7.

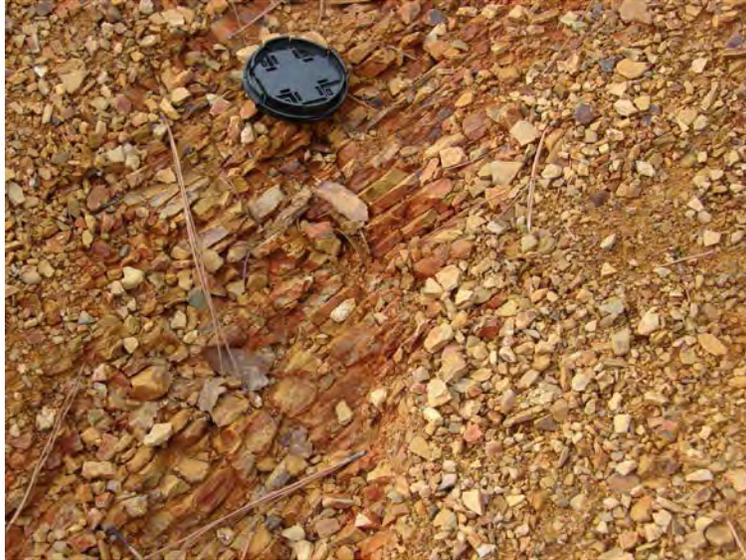
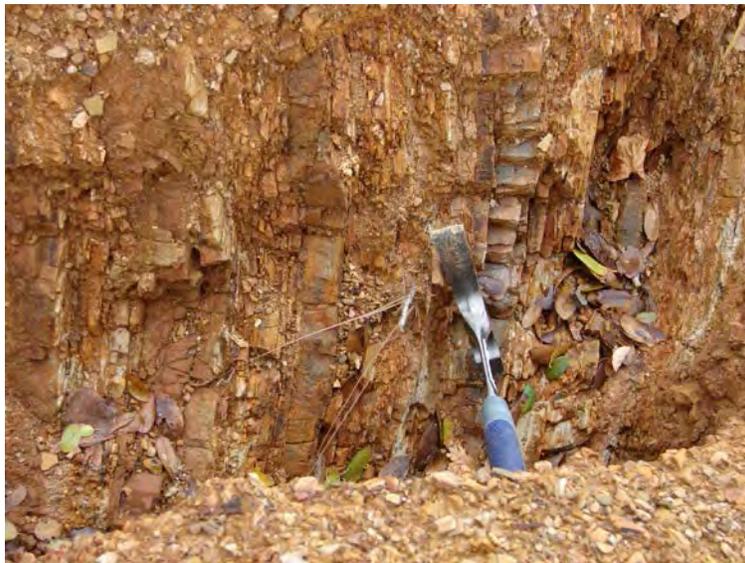
beds are less than 0.5 inches. Surface exposures of the mudstone are friable to moderately well indurated and are slightly to moderately weathered (Photographs 9 and 10). Apparent drag folding near location WP0053 (Photograph 11) suggests faulting in this area. Measured orientations of bedding planes in this area ranged from an azimuth of 229 degrees to 349 degrees with a dip of 37 degrees to 60 degrees to the northeast.

Photograph 9 – Kennett Formation – Mudstone

Photograph 10 – As above

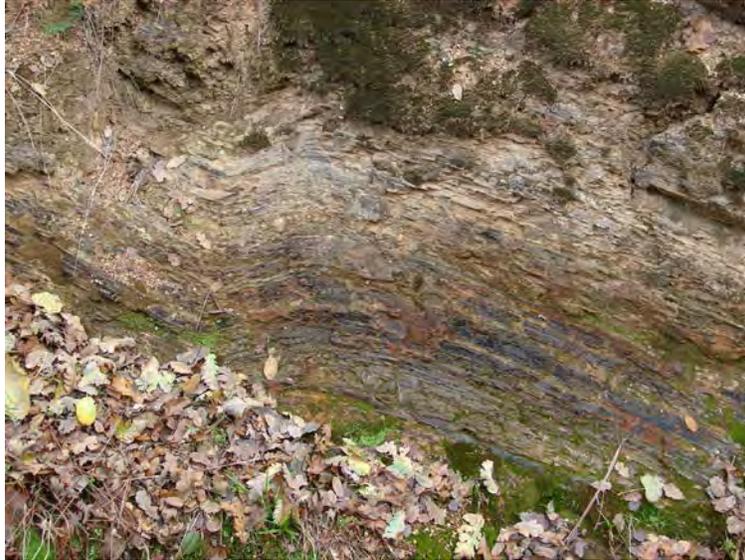
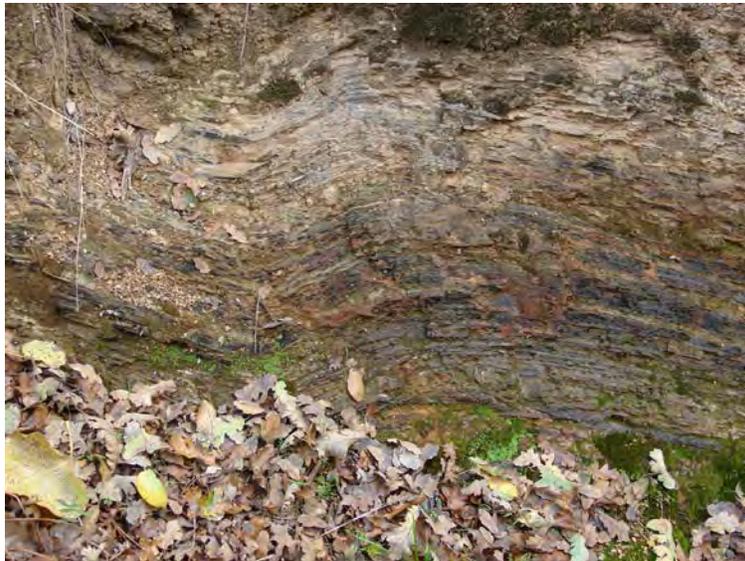
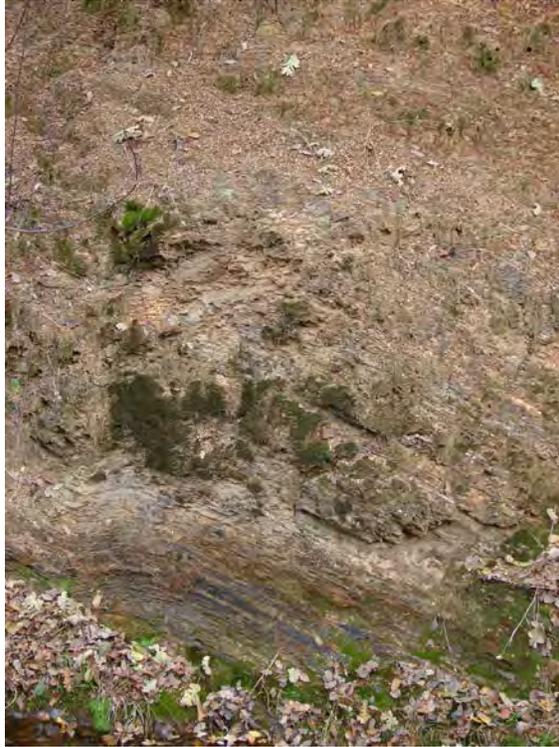
Photograph 11 – Kennett Formation – Drag Folding, eastern portion of Site.

Photograph 12 – As above.

Photograph 13 – As above.

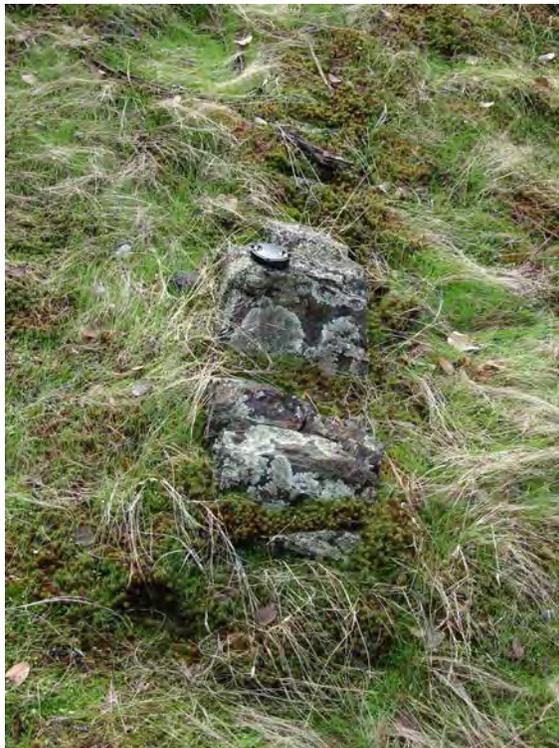
Photograph 14 – Kennett Formation, Black Cherty Slate

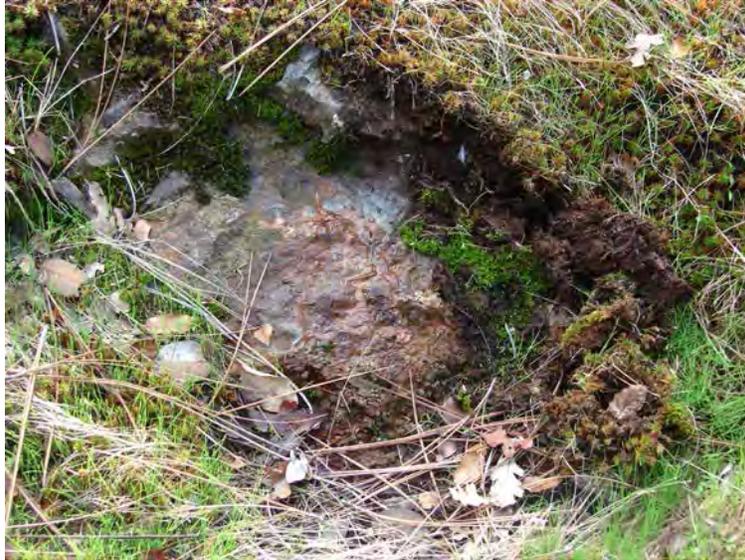
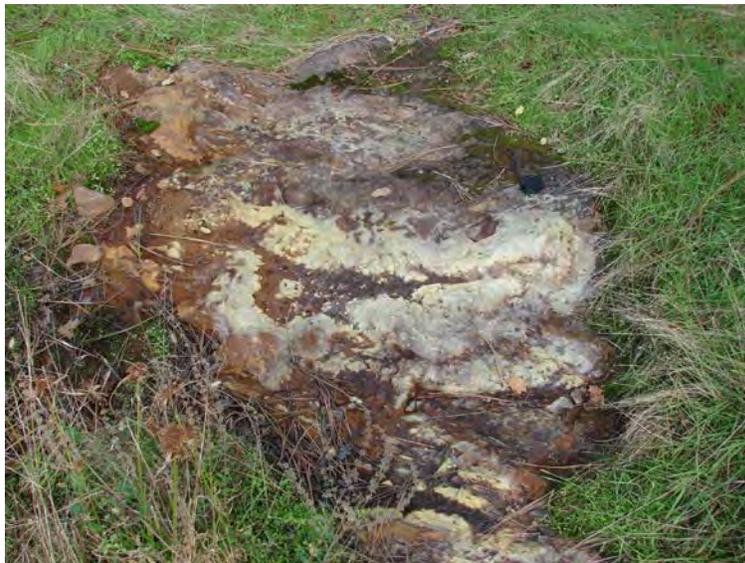
Photograph 15 – Kennett Formation. Water Seepage Visible

Photograph 16 – Kennett Formation.

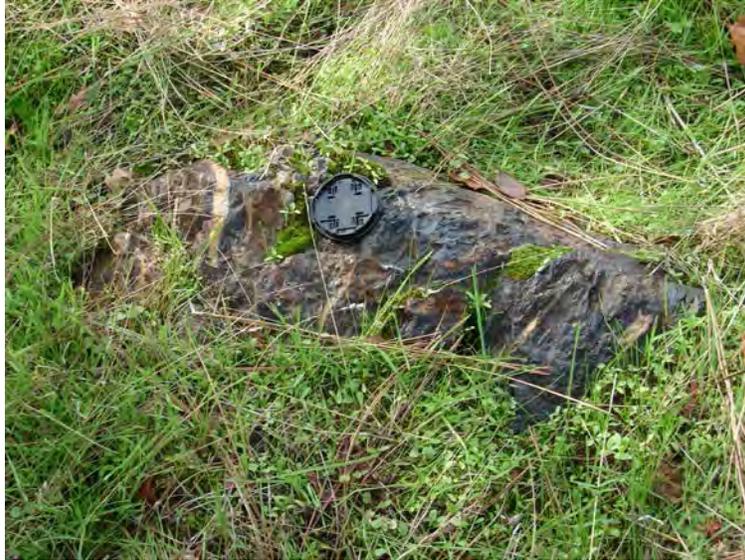
Photograph 17 – Kennett Formation – Banded Chert.

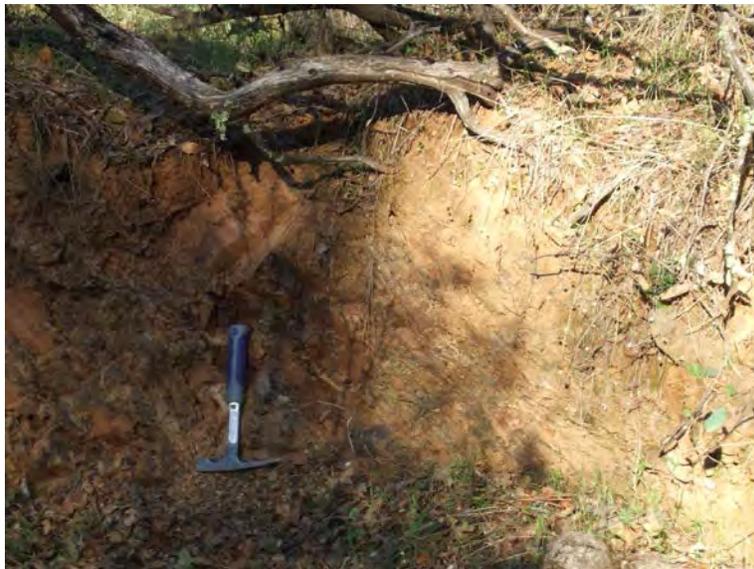
In the central portion of the site (locations WP0054 through WP0057, WP0065, and WP0075 through WP0082) the Kennett Formation consists of well indurated mudstones and black slaty chert beds. Bed thicknesses are up to 1.5 feet. Near location WP0080 folding is observed with fold axis trending at 320 degrees with a 19 degree dip to the north (Photograph 30). Near location WP0057 an excavated area that could be a filled in adit was observed (Photographs 14 through 18). In this area the Kennett Formation consists of a black cherty slate with some quartz veining. Fine grained (only observed using hand lens) pyrite mineralization was also observed. Evidence for groundwater seepage in this area was observed from reddish orange mineral staining on rock surfaces (Photograph 18).

Photograph 18 – Kennett Formation – Mudstone.

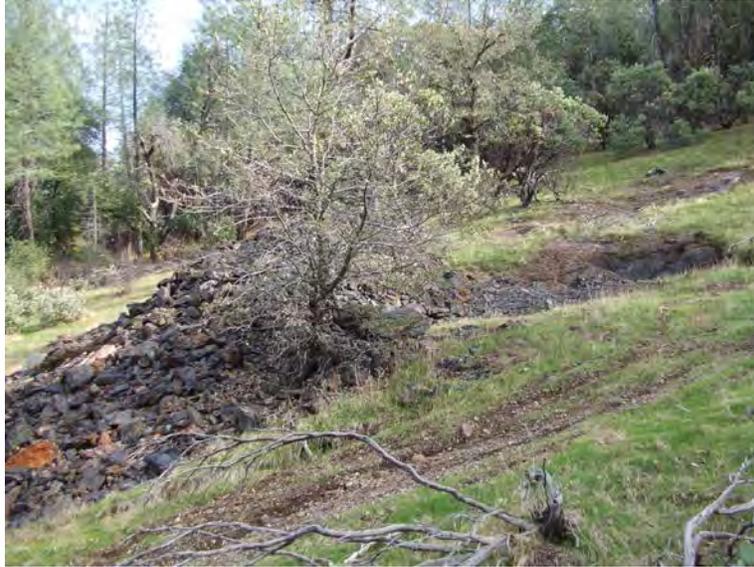
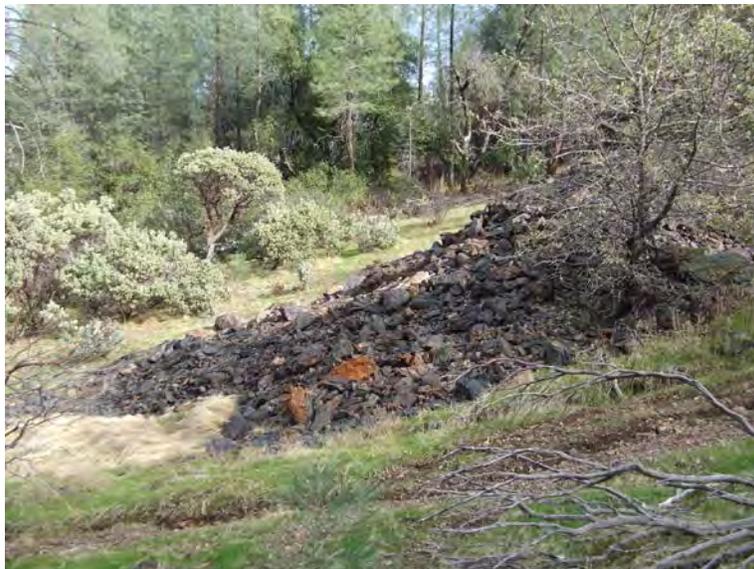
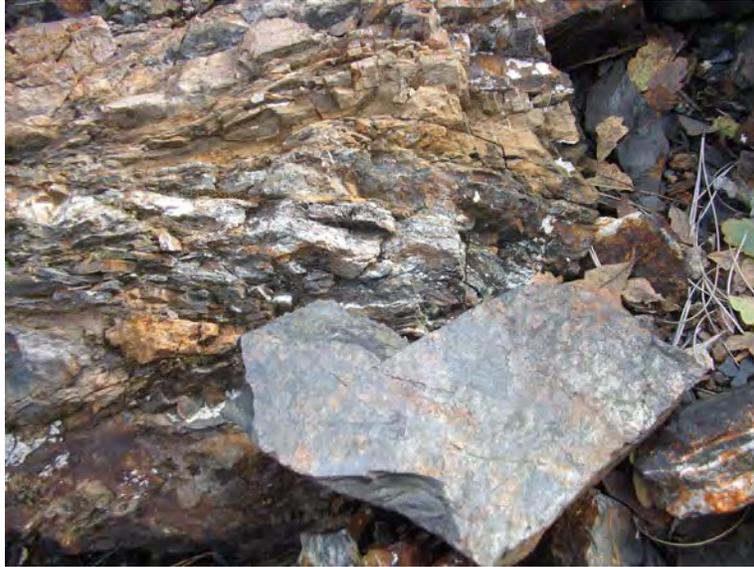
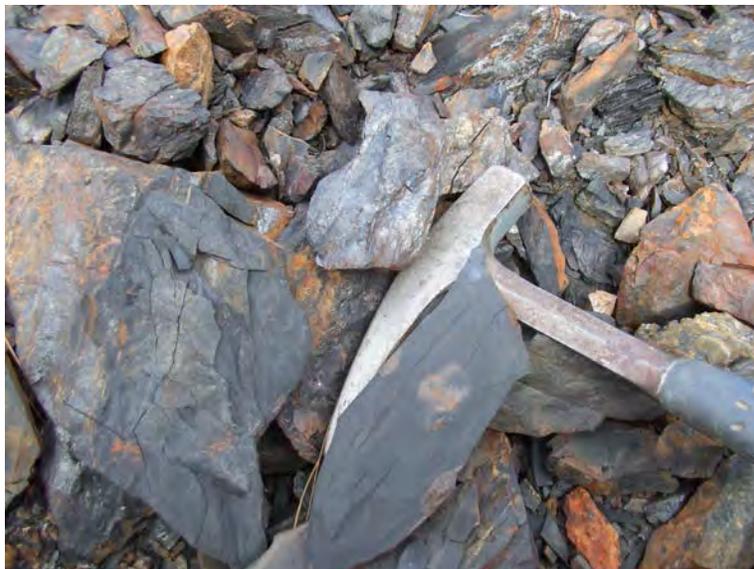
Photograph 19 – Excavation area – Kennett Formation.

Photograph 20 – As above

Photograph 21 – Close up of excavate material. Alteration apparent.

Photograph 22 – As above.

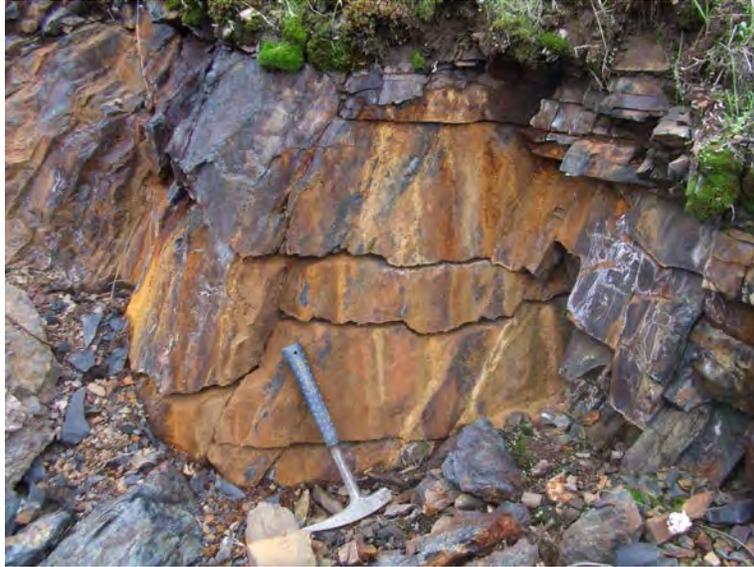
Photograph 23 – Adit area with evidence of water seepage.

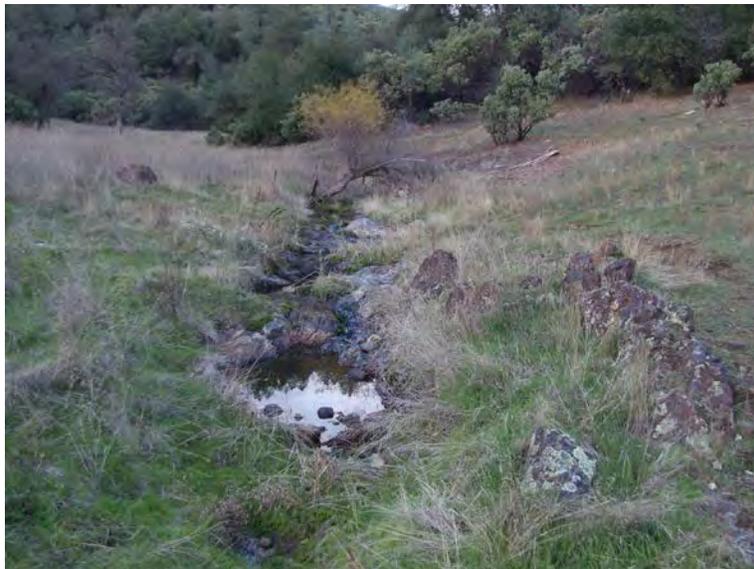
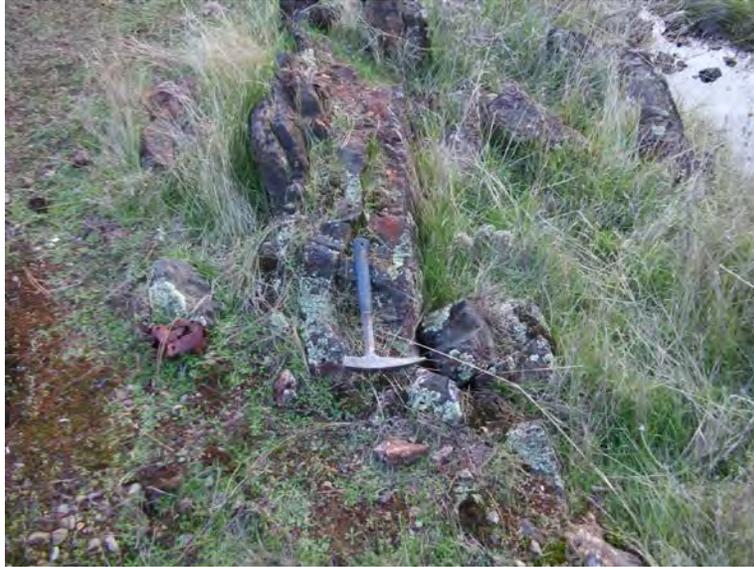
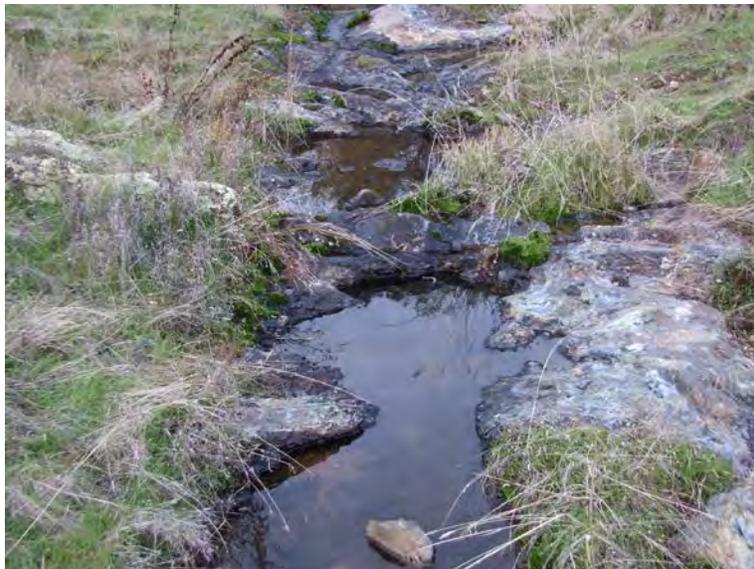
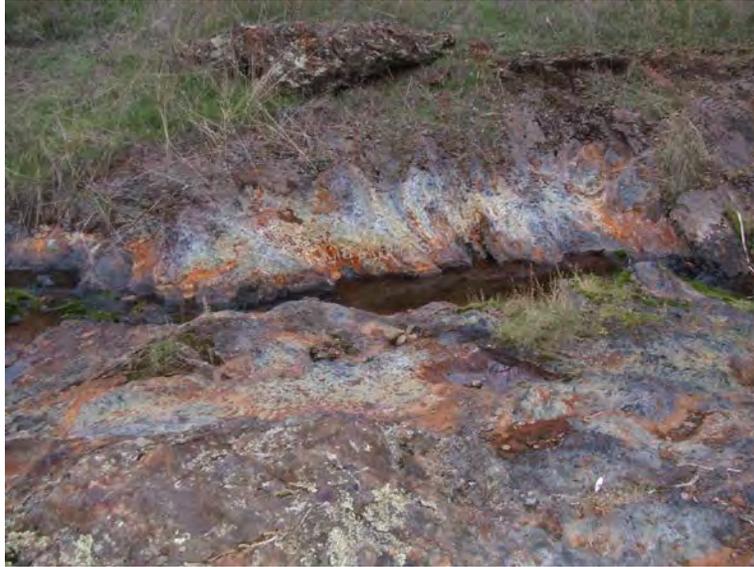
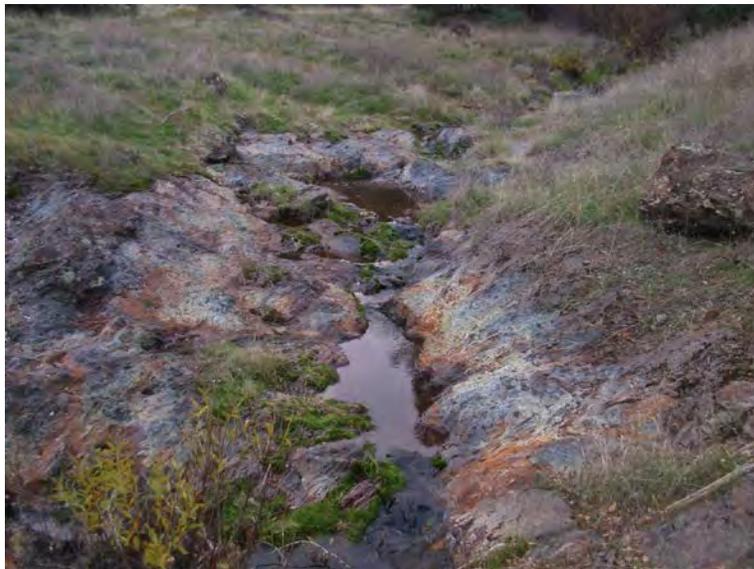
A shear zone within the Kennett formation was observed within stream channels at locations WP0071 to WP0082 (Photographs 26 to 30). In this area, the Kennett Formation consists of a well indurated black cherty slate with minor quartz veining that has been extensively folded and faulted. In this area, the trend of the creeks appears to be in line with the trend of fold axis measured at an azimuth of 320 degrees. The apparent dip of the fold axis near point WP0080 was measured at 19 degrees to the northwest. Water within the creeks was only observed to be flowing in the area of the shear zone. Flow in this area was estimated at approximately 20 gallons per minute. No water was observed flowing in the creek past point WP0082.

Photograph 24 – Kennett Formation Shear Zone – Water Flowing in Creek.

Photograph 25 – As above. Evidence of folding in this area.

Photograph 26 – As above. Water Flowing in area.

Photograph 27 – As above.

Photograph 28 – As above.

- One test well drilled in the area of the Kennett Formation shear zone where water was observed during drilling.
- One test well drilled in the eastern portion of the Bass Mountain Diabase where open fractures were observed in bedrock outcrops and the area could receive significant recharge from higher elevations. The Mountain Gate Water District reported that an unsuccessful test hole was drilled within the Bass Mountain Diabase.
