ADDENDUM  
FIELD INVESTIGATION REPORT  
HYDROLOGY ANALYSIS  
3M REDDING HARD-ROCK AGGREGATE QUARRY  
SHASTA COUNTY, CALIFORNIA

Prepared for  
Resource Design Technology, Inc.  
January 21, 2010

BROWN AND CALDWELL

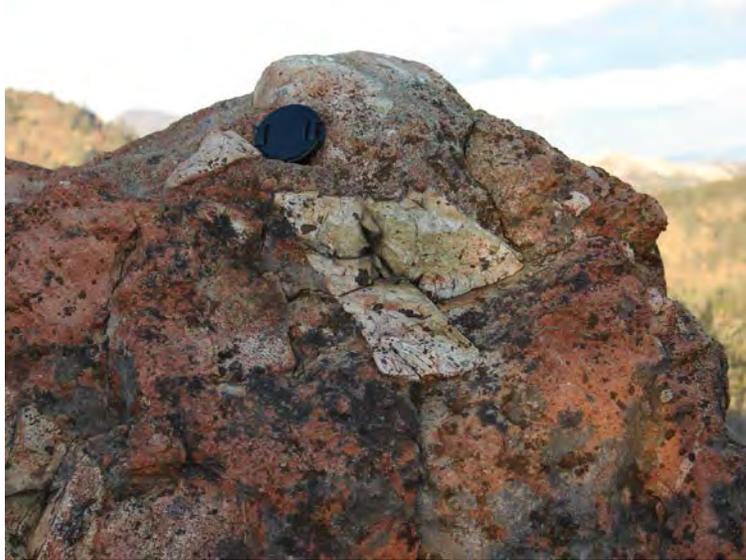
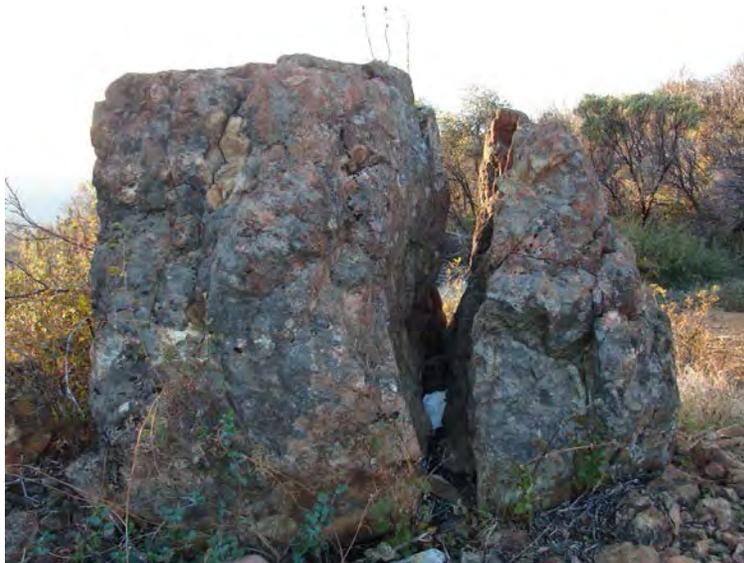
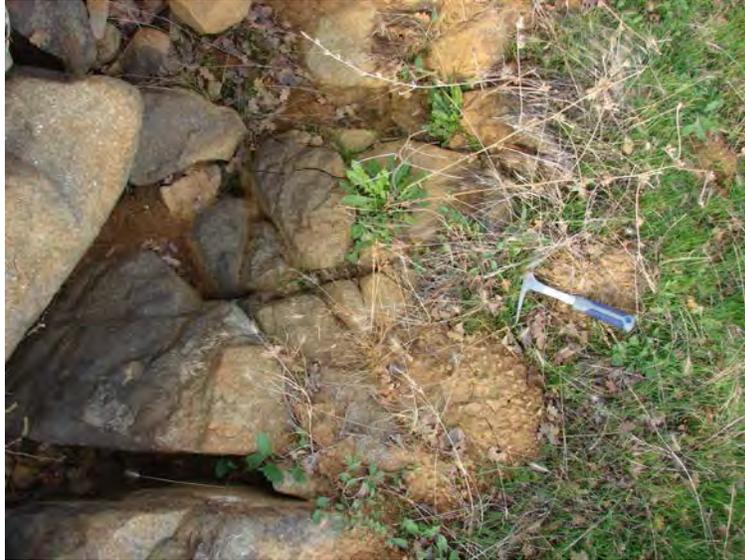
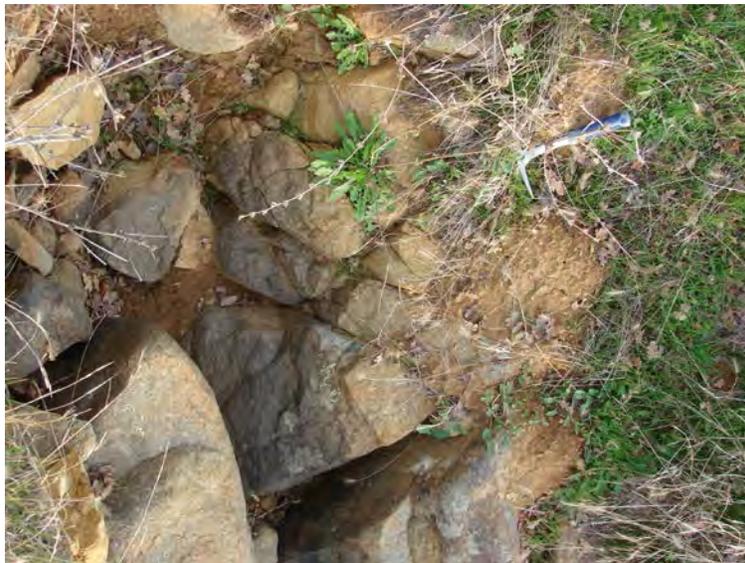
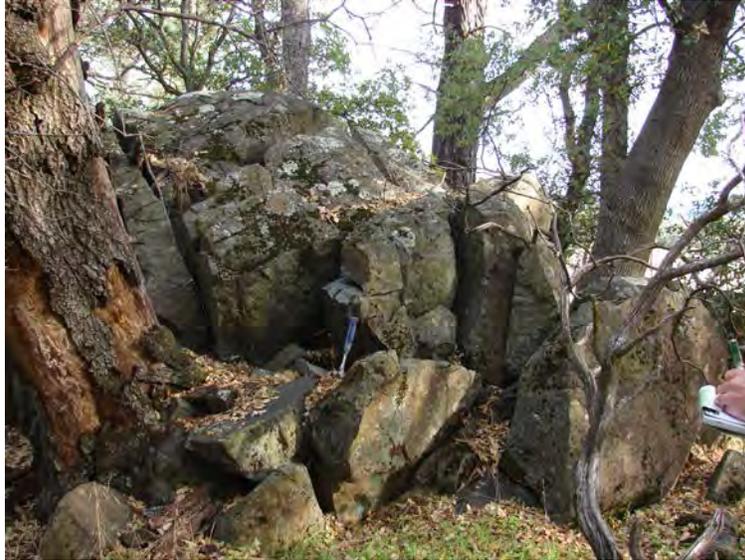
In surface exposures, the Bass Mountain Diabase is a well indurated fine grained greenstone, brown on surface exposures and green on fresh surfaces. Soils developed within this formation yield a deep red color. Mostly fine, less than 0.5 inches diameter, quartz and plagioclase phenocrysts are apparent throughout this unit and distinguish it from the greenstones of the Copley Greenstone. A large plagioclase phenocryst near location WP0042 is shown on Photograph 29. Photograph 34 shows a limestone xenolith (country rock material) observed near location WP0045.

Fractures and joints within the Bass Mountain Diabase are widely spaced (6 to 10 inches) and open. Many fractures are filled with sediment. Two sets of conjugate fracture patterns were observed in this unit (Appendix E), one with an average trend of about 320 degrees azimuth and another with an

Photograph 29 – Bass Mountain Diabase. Large Plagioclase Phenocryst visible.

Photograph 30 – Bass Mountain Diabase – Typical Outcrop in eastern area of site.

Photograph 31 – As above.

Photograph 32 – As above.

Photograph 33 – As above with typical jointing visible.

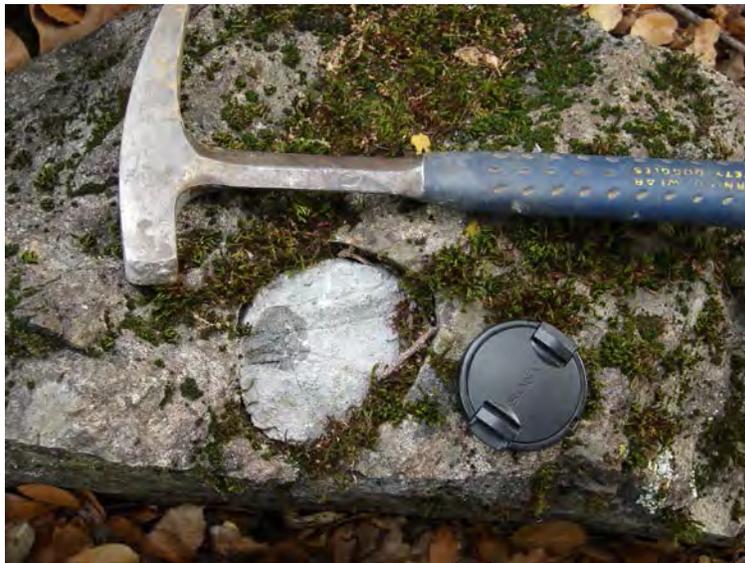
Photograph 34 – Bass Mountain Diabase with Xenolith (country rock) of limestone.

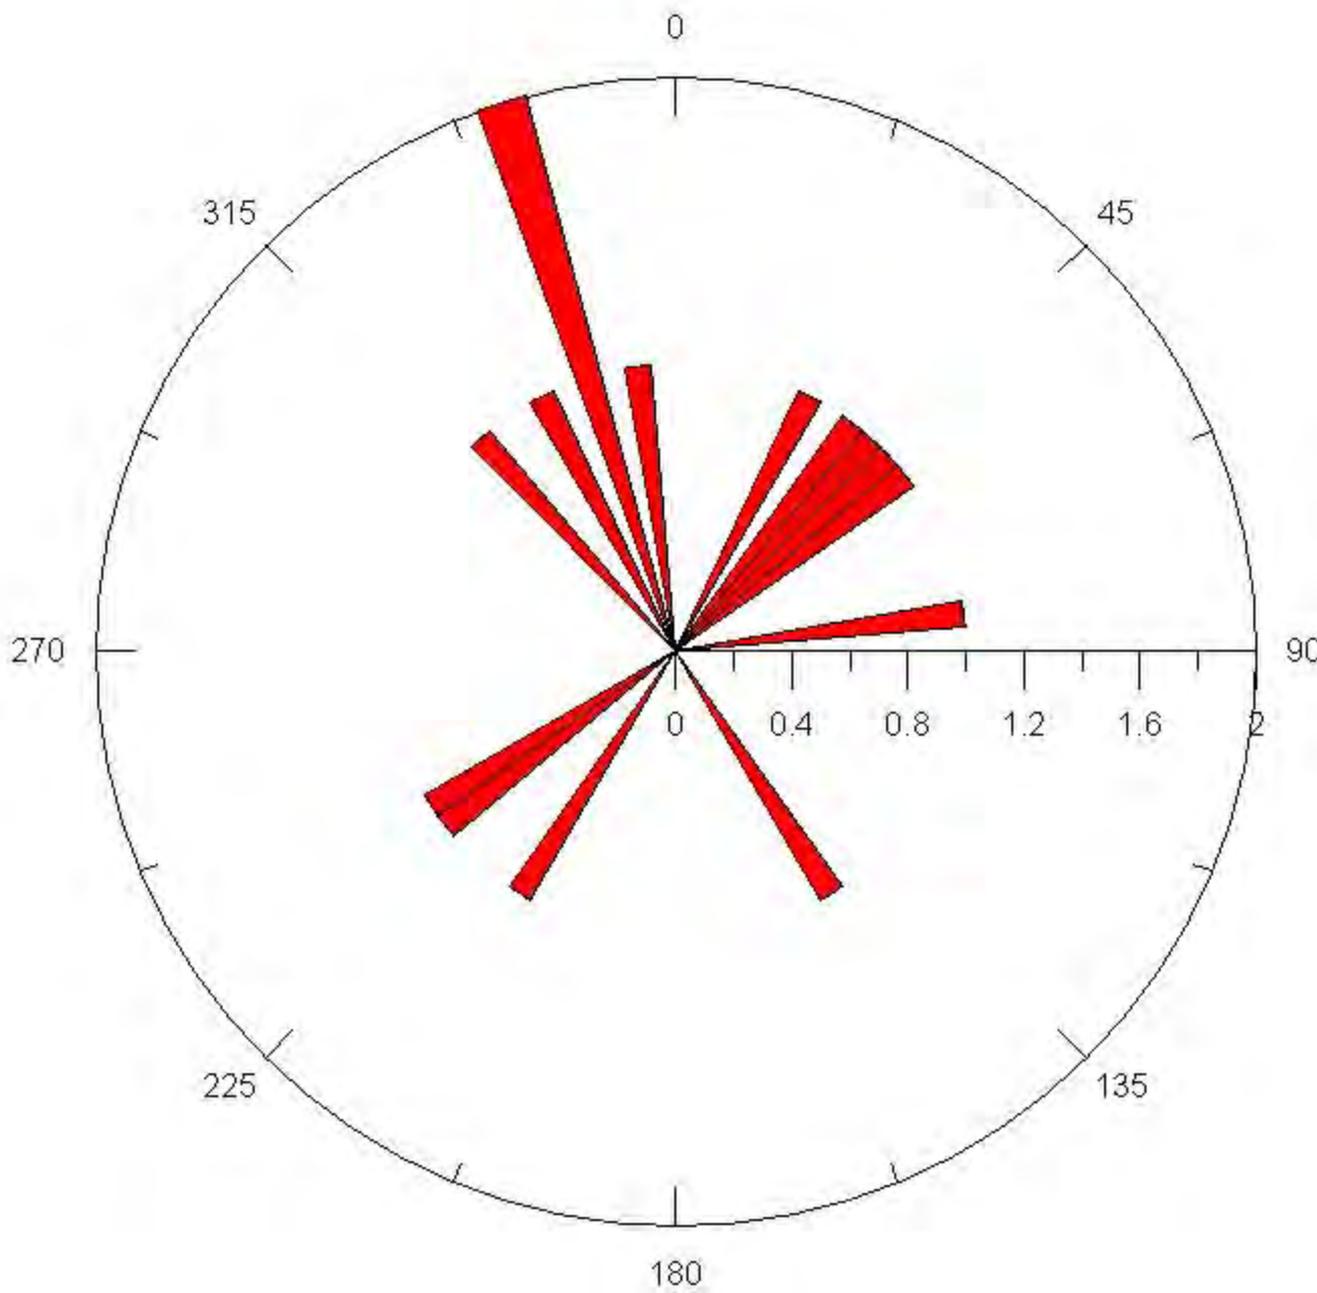
average trend of about 45 degrees azimuth. No water was observed seeping from surface fractures of the Bass Mountain Diabase. However, as discussed in Section 3.1, a small amount of water (generally less than 1 gpm) was produced from well MW-1 and B-1 located in the area of the proposed South Pit.

Bass Mountain Diabase  
Number of values 15  
Minimum 27  
Maximum 352  
Mean 187.7

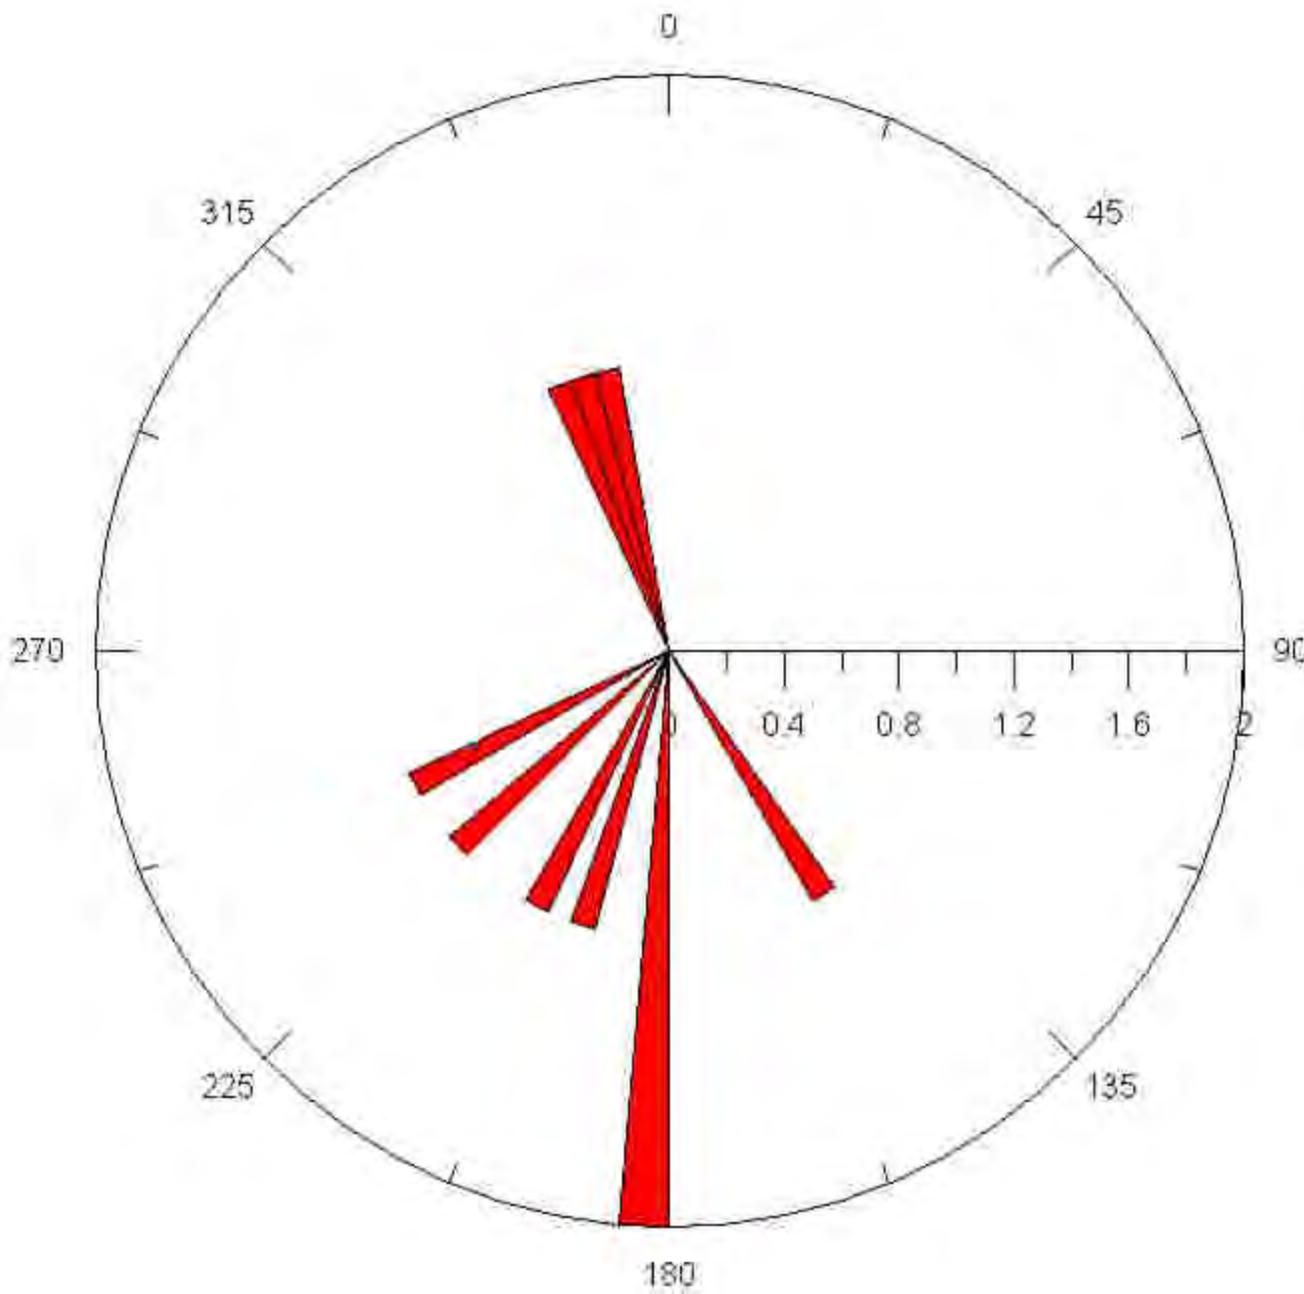
# Kennett Formation Bedding Planes

In areas outside of the shear zone and area of the apparent adit, fractures are closely spaced and closed or clay filled and are generally developed along bedding planes. Appendix E presents a rose diagram illustrating the attitude of bedding planes for the Kennett Formation. A total of 10 attitudes or orientations were collected. Measurements were recorded as azimuth directions 0 to 359 degrees. A 0 degree measurement is due north and a 180 degree measurement is due south. The average mean orientation of these bedding planes is 242 degrees azimuth. The dip of these planes ranged from 11 degrees to the northwest to 85 degrees to the west.

Number of values 10  
Minimum 150  
Maximum 349  
Mean 242.8
